PHILIPP SPEISER

INSTITUT FÜR BAU- UND STADTBAUGESCHICHTE, TU-BERLIN

The Sultan al-Nāṣir Muḥammad Madrasah in Cairo: Restoration and Archaeological Investigation

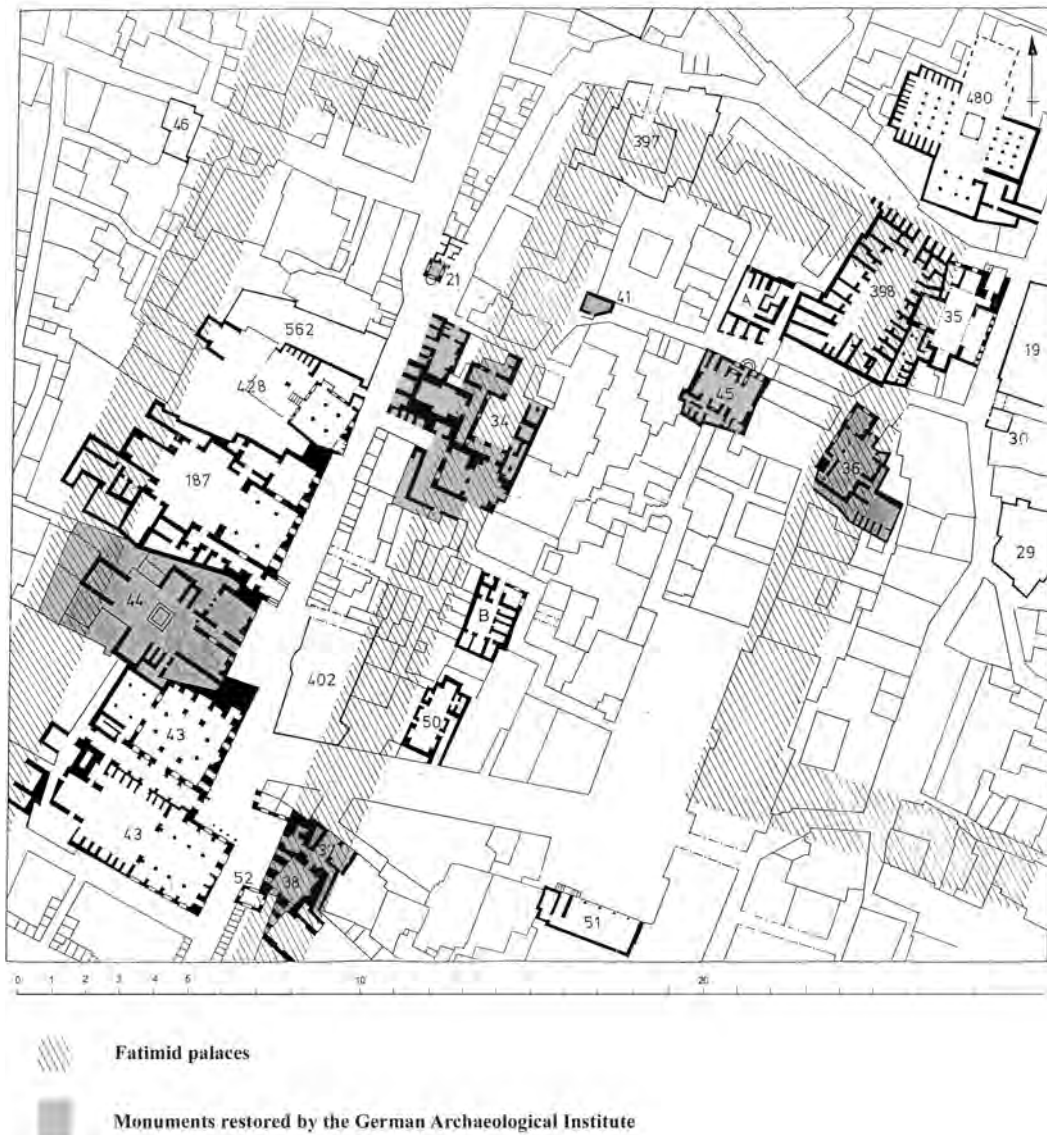
Fig. 1. Key map: no. 44, Madrasah of al-Nāṣir Muḥammad; no. 43, Madrasah of Maṣṣūr Qalāwūn; no. 187, Madrasah of Barqūq (drawing by N. Hampikian/Ph. Speiser)

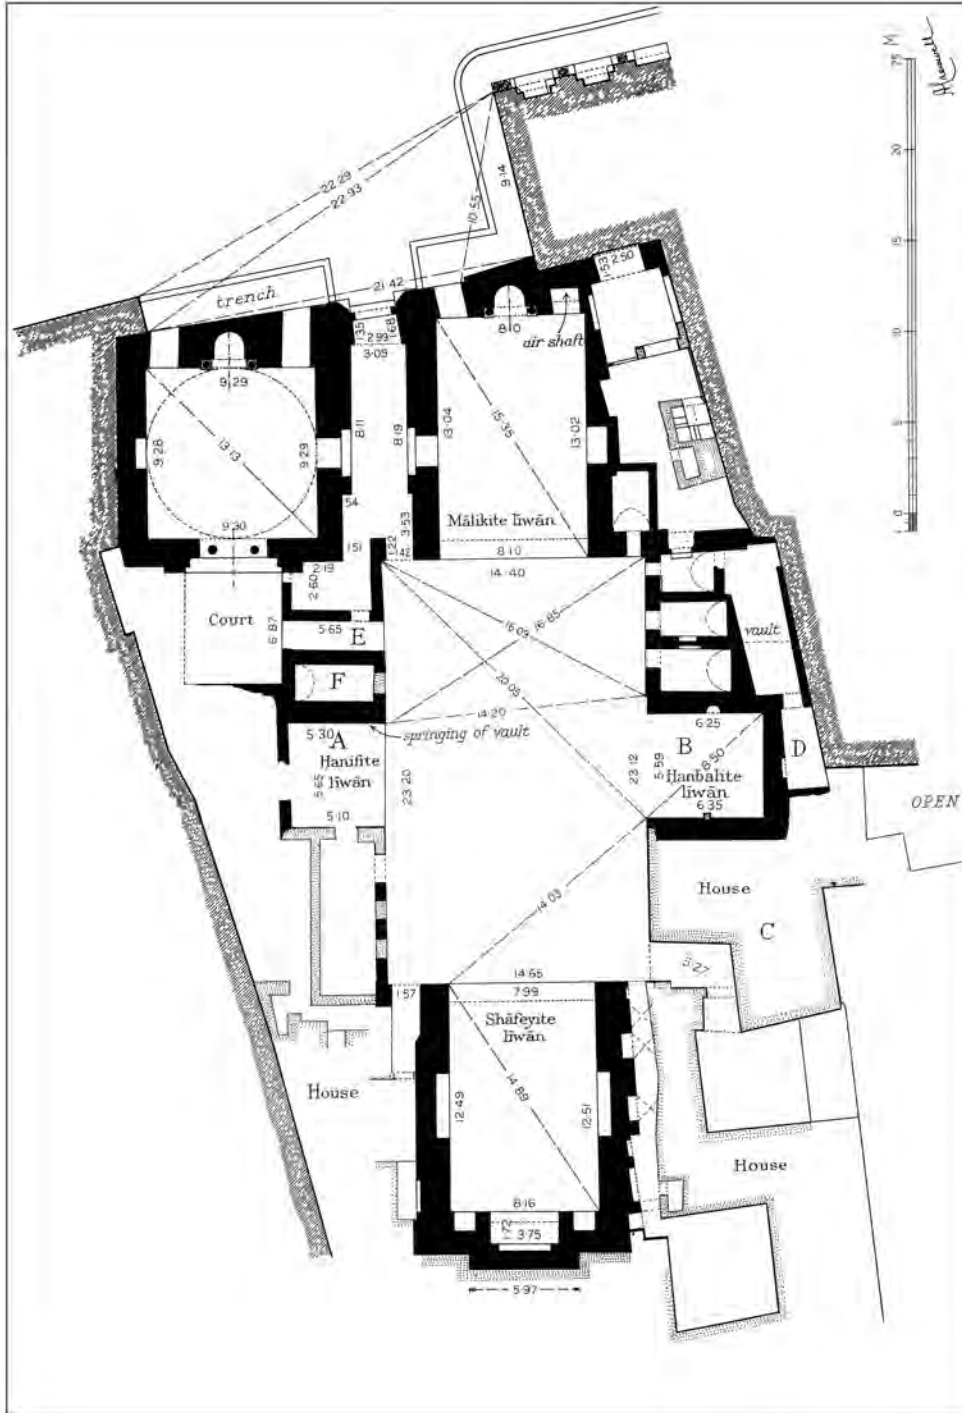
Fig. 2. Madrasah of al-Nāṣir Muḥammad, ground plan, 1959 (by K. A. C. Creswell)

The excavations confirmed the conjecture that the ground-plan provided for four *iwāns*. However, stratigraphic analysis showed that cells and remains of secondary or minor *iwāns* visible before 1985 on the long side of the madrasah and marked on Creswell's plan as Mamluk likely date from the Ottoman period (1517–1798) and later.³² The madrasah does not seem to have been properly maintained after the donor's death; to judge from the pottery finds, extensive restoration work was carried out in the sections along the long sides at a time that cannot be precisely ascertained. Further, the minaret was given a new tip and the mausoleum may have been topped with a wooden dome.

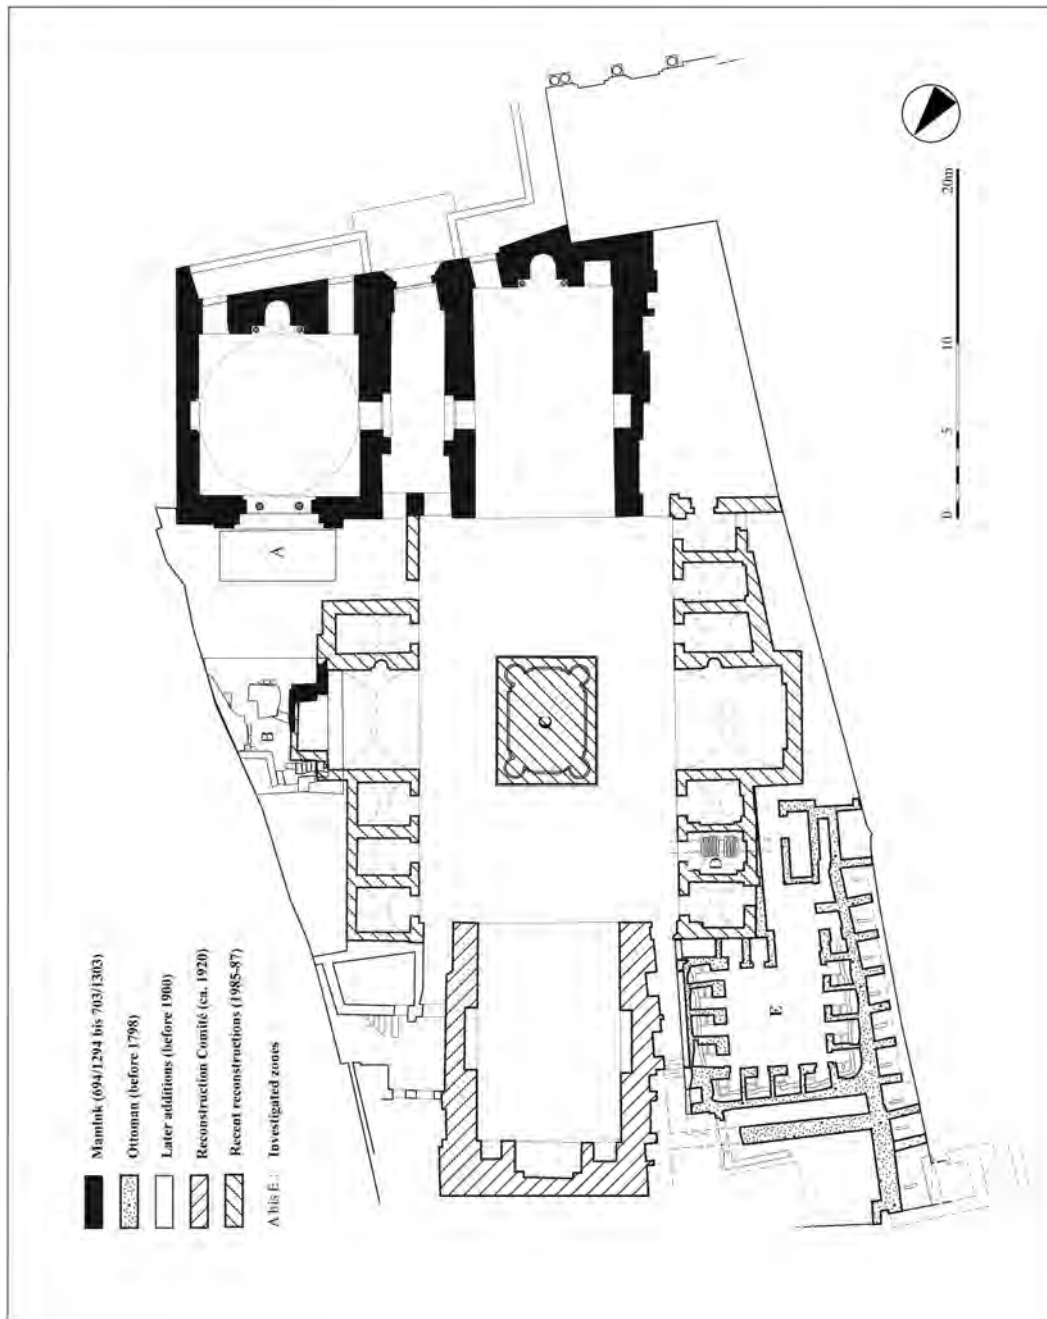
Fig. 3. Madrasah of al-Nāṣir Muḥammad, ground plan after excavation in 1985–89 and 1998–2004 (by M. Lehner, Ph. Speiser, and G. Nogara)

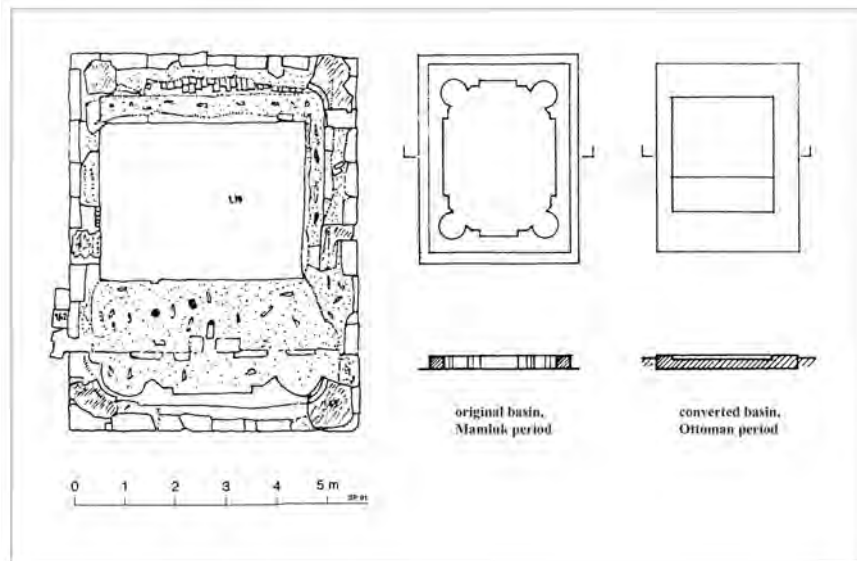
Fig. 4. Madrasah of al-Nāṣir MuḤammad, zone C courtyard, fountain (by Ph. Speiser)

After the removal of a layer of rubble more than one meter high in the inner courtyard, the remains of a rectangular water basin (3.75 by 2.9 meters) were revealed at its center.²³ The inner corners of the basin were rounded, a feature characteristic of the basins found in Fatimid layers in Fustat. The basin has a rim approximately one meter high of bonded brick, which was rendered inside with a water-resistant or waterproof lime mortar (an aggregate of brick dust or charcoal ash). It was finished off at the top with limestone slabs, of which, however, only a few pieces were found. At some time, the basin had been partly filled in with bricks. The fresh water needed to fill it was probably brought from one or more subterranean cisterns via a lined shaft sunk several meters deep under the courtyard. Since there are no traces of individual places for ablution with the usual drains, the water basin is unlikely to have been used originally for ablutions. Instead, the reflecting surface of the water was perhaps a design feature of the courtyard.²⁴ There are similar basins in the Nūr al-Dīn Madrasah and Mārīstān (built 567/1162) and the ‘Ādilīyah Madrasah (built 623/1219), both in Damascus.²⁵

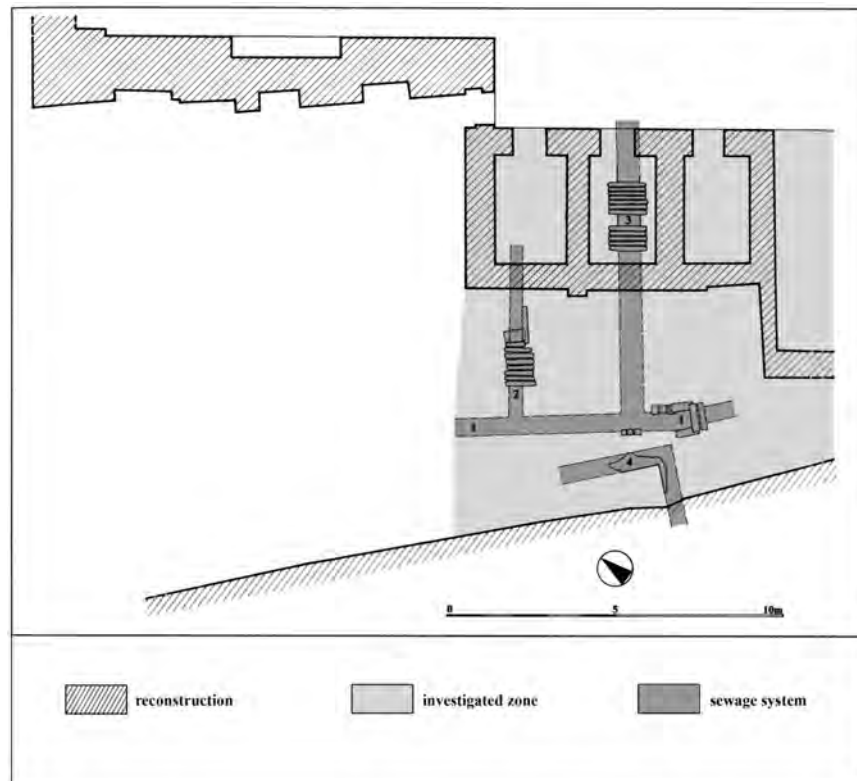
Fig. 5. Madrasah of al-Nāṣir MuḤammad, zone D, phase 1 (by G. Nogara)

The south-west side of the inner courtyard was cleared of later additions, which were all in a precarious state, and partly excavated. This excavation made it possible to ascertain the Mamluk ground-plan to a large extent from the alignment of its foundations. It contained a side *iwān*, identical to the one on the opposite side, with three small rooms, most likely dormitory cells, on its left side. On the site of a demolished house, adjacent to the right (north-west) of the side *iwān*, the foundations of three more dormitory cells were uncovered, as well as remains of a linking passage running behind them, in which some of the limestone flag flooring has survived. Beneath two of the cells two sewage shafts were found, which are in part aligned with the inner courtyard. These shafts belong to a pre-Mamluk building phase and are part of an elaborate drainage system centered at some distance to the south-west.²⁶

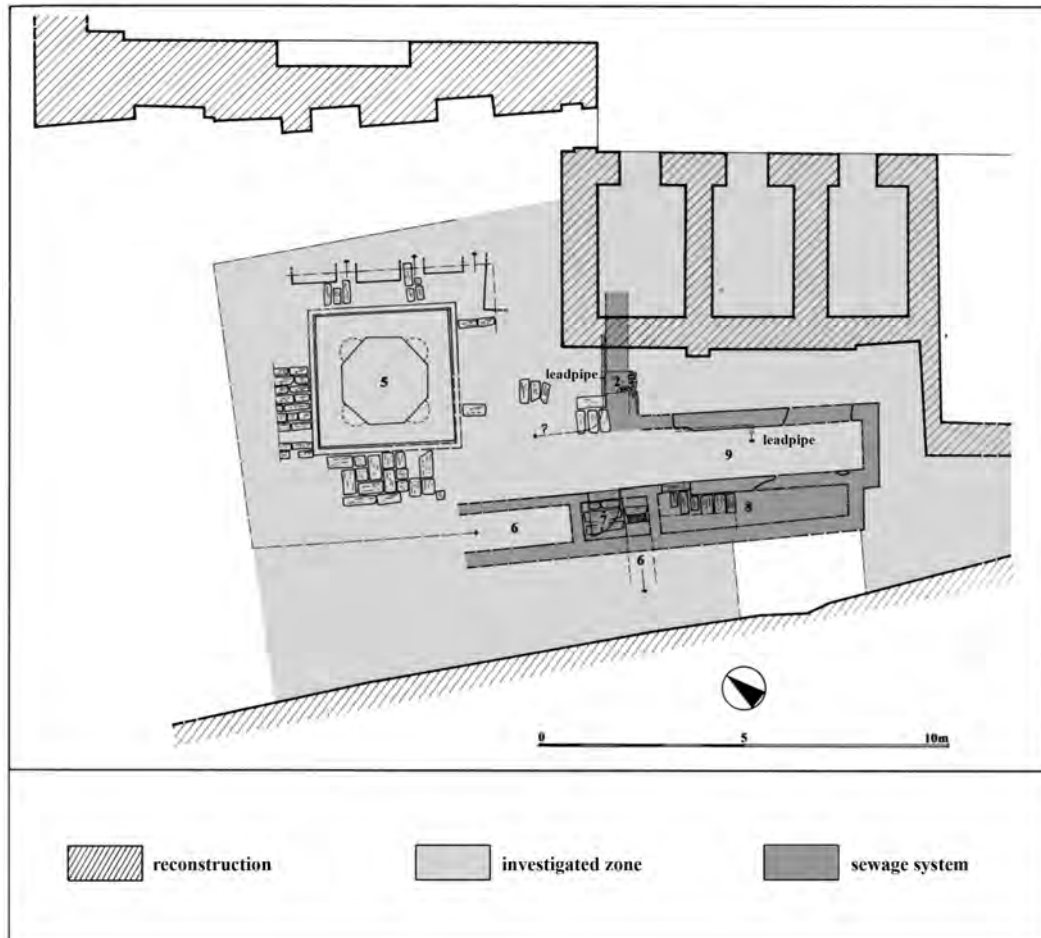
Fig. 6. Madrasah of al-Nāṣir Muḥammad, zone D and E, phase 2 (by G. Nogara)

Within a jumble of wall remains (spoils from several damaged Mamluk and Ottoman structures which are beyond the scope of this work), a continuous, slightly trapezoidal complex showed up clearly. On each of three sides it has the remains of four identical cells or cubicles, all of which open on to what was probably an open courtyard measuring 5.5 by 5.5 meters.

The above-mentioned twelve cubicles are almost identical in form, and all have a surface area of almost 1.5 square meters. At the back, each has a seat built of two blocks of limestone. Between the two blocks of limestone is an opening that drains into the sewage system below. Each of the cubicles, most likely covered at one time by a vault or dome, enters onto the courtyard through a simple wooden door. Along the right-hand side wall of each cubicle runs an open water channel, which has a brickwork rim up to 0.4 meters high. It is unclear how the fresh-water channel was fed, since there are no indications of a cistern nearby; perhaps it was filled at its highest point from skin water bags or buckets. In two cubicles, remains of a floor from an earlier building phase were found about 0.3 meters deeper. An even earlier building phase was found beneath the north-eastern row of cubicles, where at least three cubicles were built on the demolished masonry superstructure of identical structures dating from the time the madrasah was built.²⁸

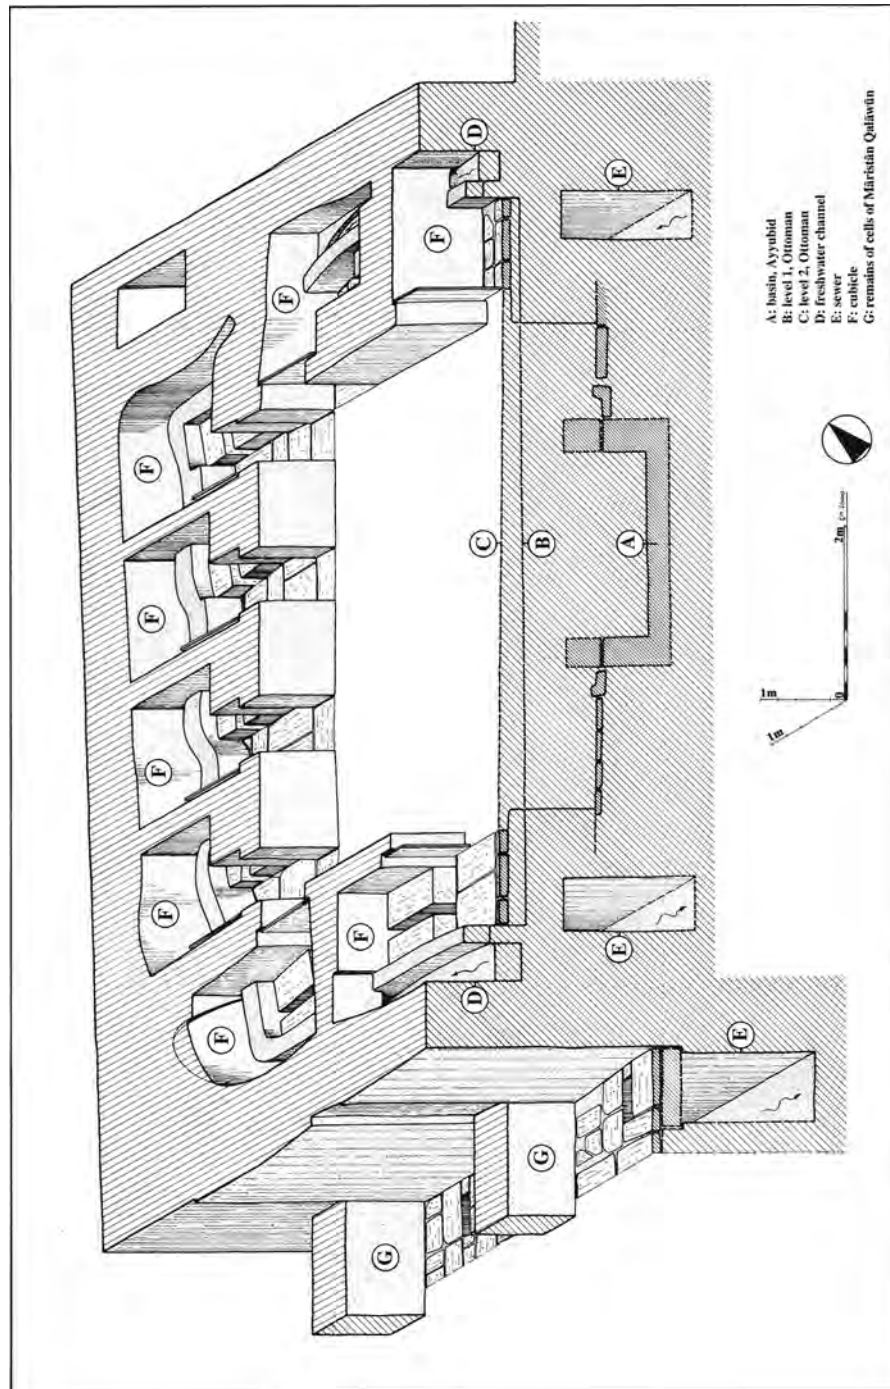
Fig. 7. Madrasah of al-Nāṣir MuḤammad, sanitary installations, axonometric reconstruction (by G. Nogara)

Virtually at the center of the courtyard, but one meter deeper than the level of the cubicles, is an octagonal water basin whose nine parts were later adapted to fit into a square rim. This represents an example of recycling, perhaps of an element from the Fatimid Western Palace. A coin that was found dates the recycling of the basin to the Ayyubid era. The structure was undoubtedly a sanitary facility. The presence of a continuous freshwater channel in most cubicles suggests they were used by the teachers and pupils for the purposes of physical hygiene.³⁰

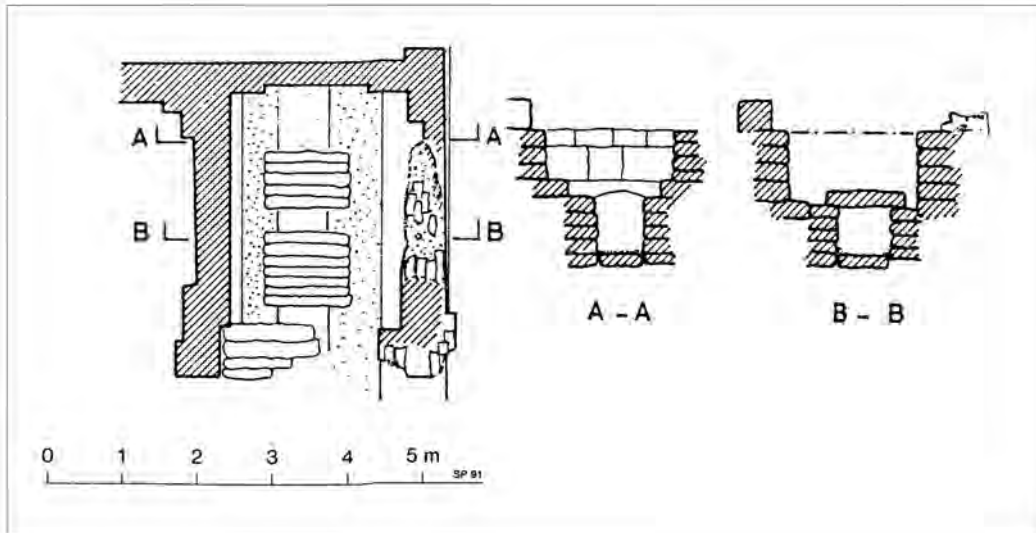
Fig. 8. Madrasah of al-Nāṣir Muḥammad, zone D, sewer details (by Ph. Speiser)

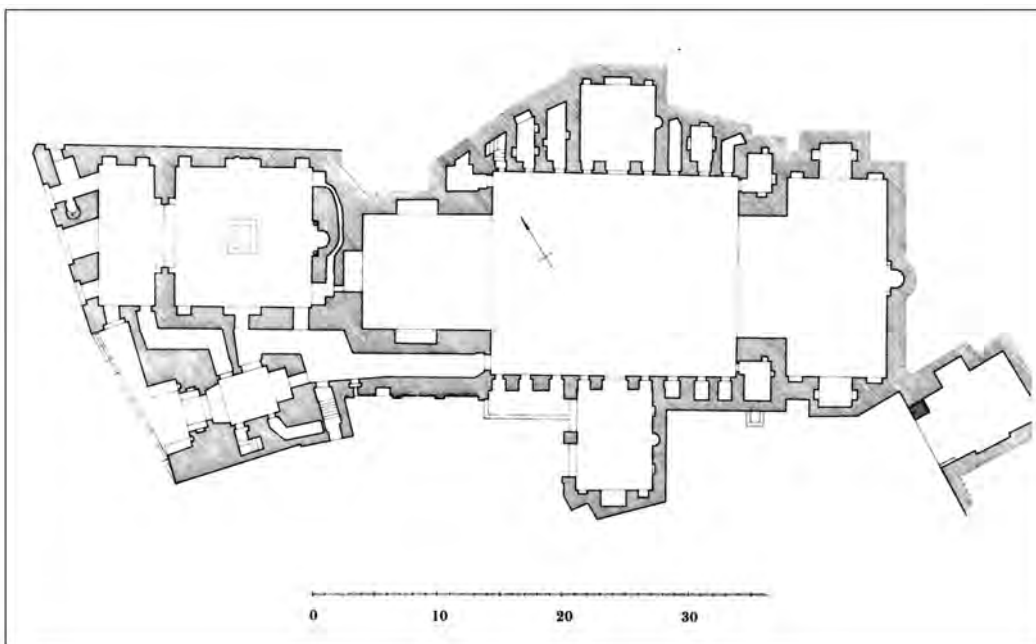
Fig. 9. Cairo, Khānqāh of Amir Baybars al-Jashnkīr (by M. Meinecke)

Despite archaeological excavation of several ground-floor rooms or at least their foundations, the floor-plan of the al-Nāṣir MuḤammad Madrasah still has gaps. Two to three storeys can be reconstructed on the basis of the window niches in the rear façade of the main *iwān*, which faces the inner courtyard. However, it is because the vertical architectural elements such as stairwells, light shafts, etc., are missing without a trace that the madrasah remains incomplete. The only possibility, therefore, is comparison by function and ground-plan with similar facilities which still have upper floors. One example suitable for such comparison is the virtually contemporaneous Baybars al-Jāshnkīr Khānqāh (706–9/1306–10), situated nearby in the Shāri‘ al-Jamaliyah.

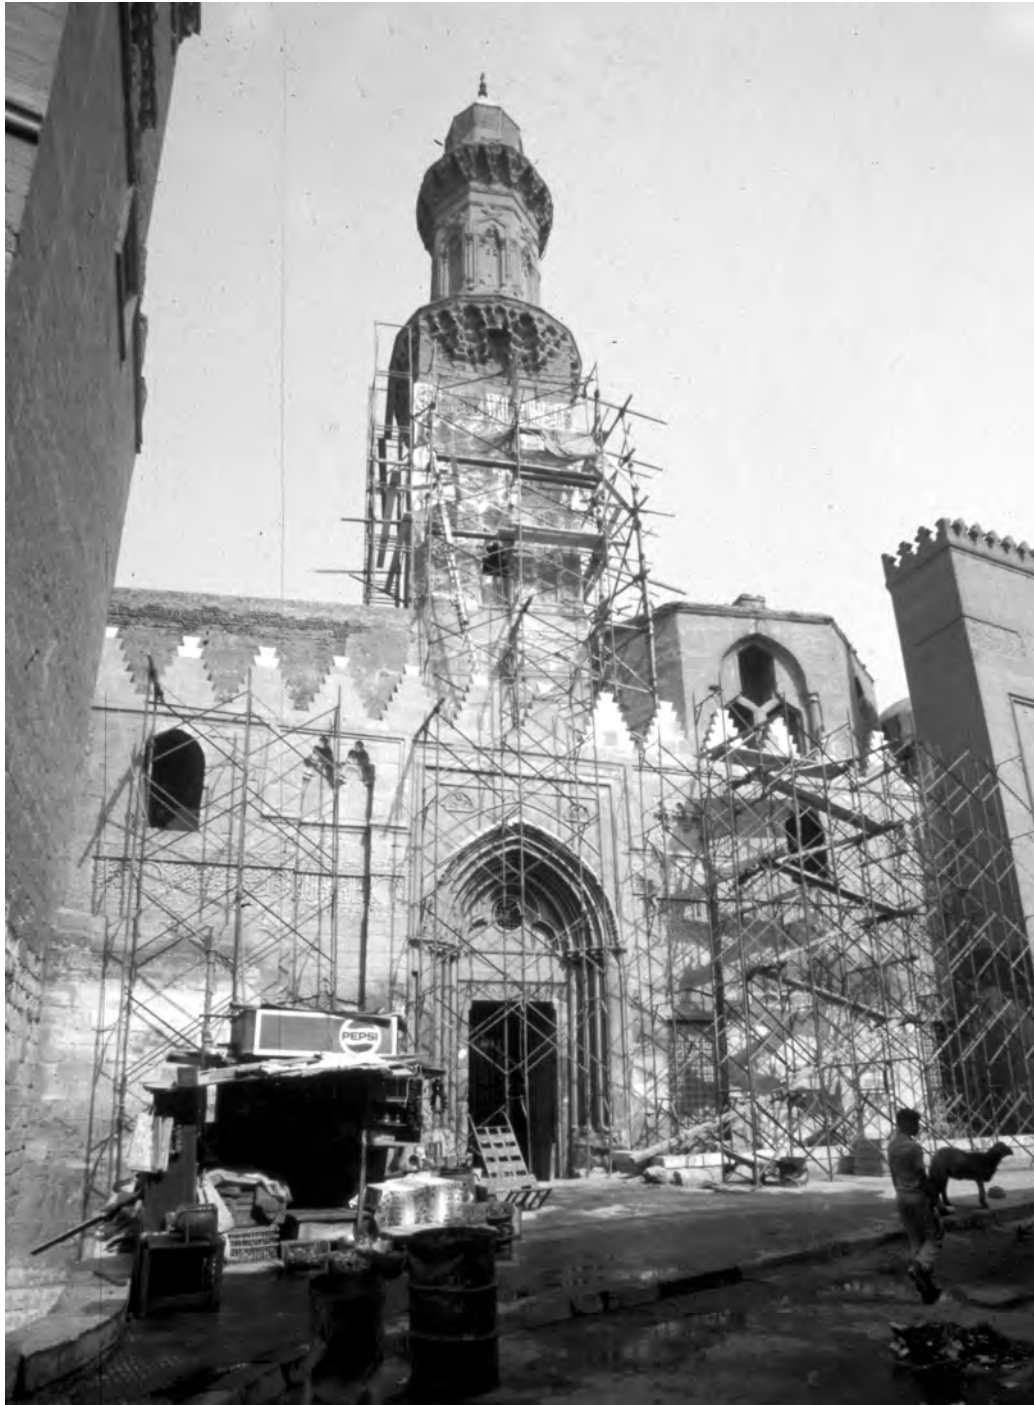
Fig. 10. Madrasah of al-Nāṣir MuḤammad, street elevation during restoration, 1986 (Speiser)

1. Securing the masonry and replacing damaged and missing parts: this affected most parts of the complex and especially the south-west wall of the qiblah *iwān*, the street façade with its unrendered ashlar masonry, and the mausoleum masonry. The crown molding of the walls and some of the crenellation on the street side had to be rebuilt.

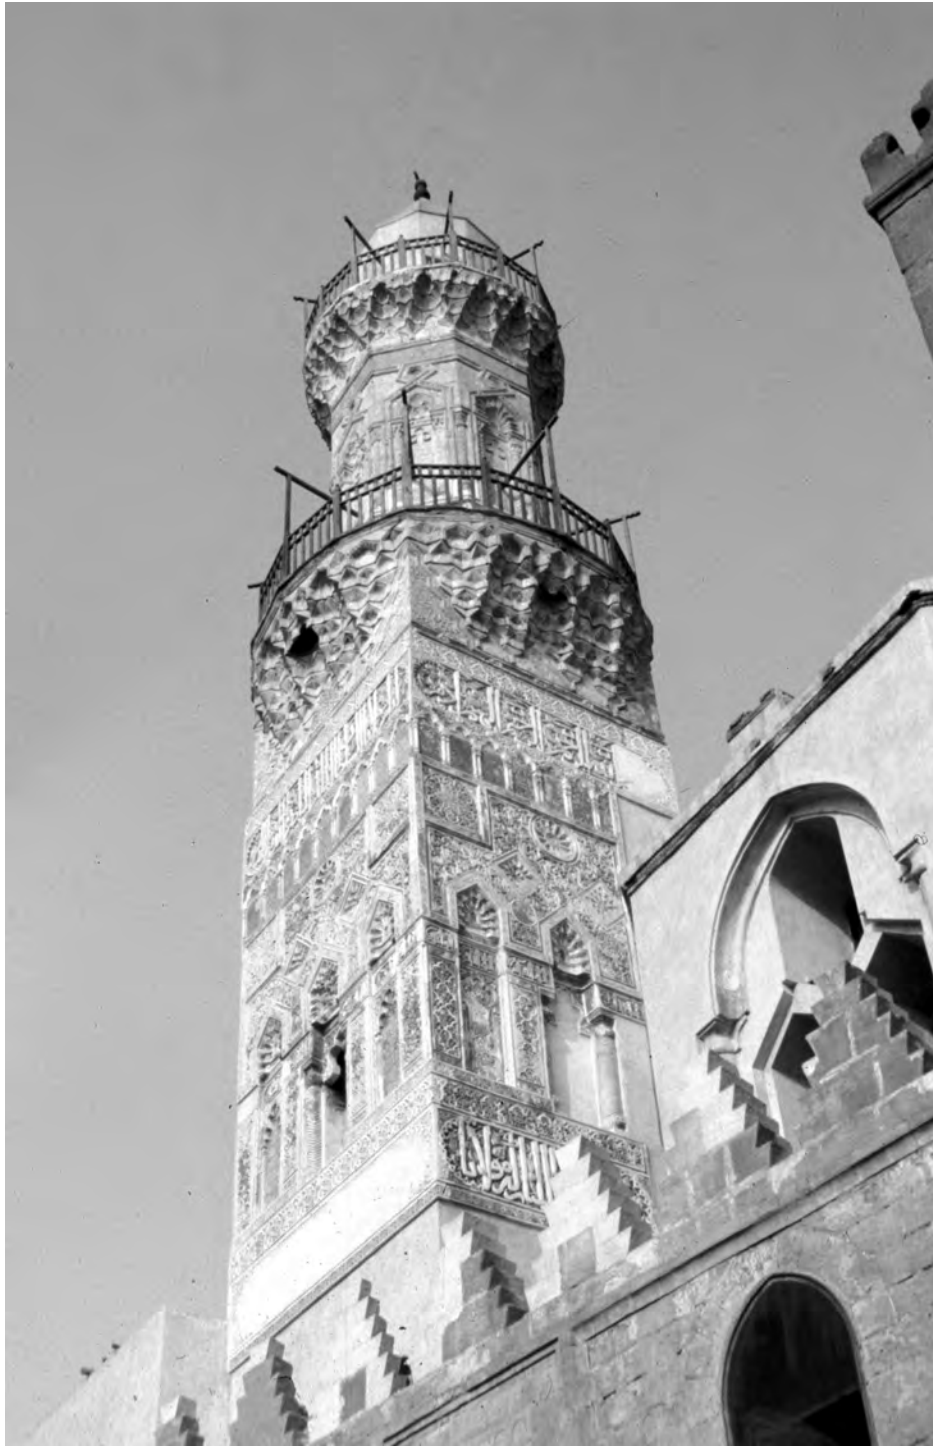
Fig. 11. Madrasah of al-Nāṣir Muḥammad, minaret, 1989 (Speiser)

- Stucco decoration: undoubtedly the largest decorated surfaces (covering many square meters) are on the minaret. In addition to very careful and time-consuming cleaning, removing later layers of plaster and securing the original structure, some parts had to be replaced. The restoration work that was carried out on the upper semi-dome of the prayer niche in the main *iwān* was particularly elaborate, since the semi-dome is clad with a complex relief in the repoussé technique. At the same time, the decorated field above the niche as well as an Ottoman decorative window were restored. Other elements of decoration that were preserved and restored are the mausoleum pendentives and the grills of high windows. The stucco rendering was also restored and completed in four window niches on the main *iwān* façade overlooking the courtyard.

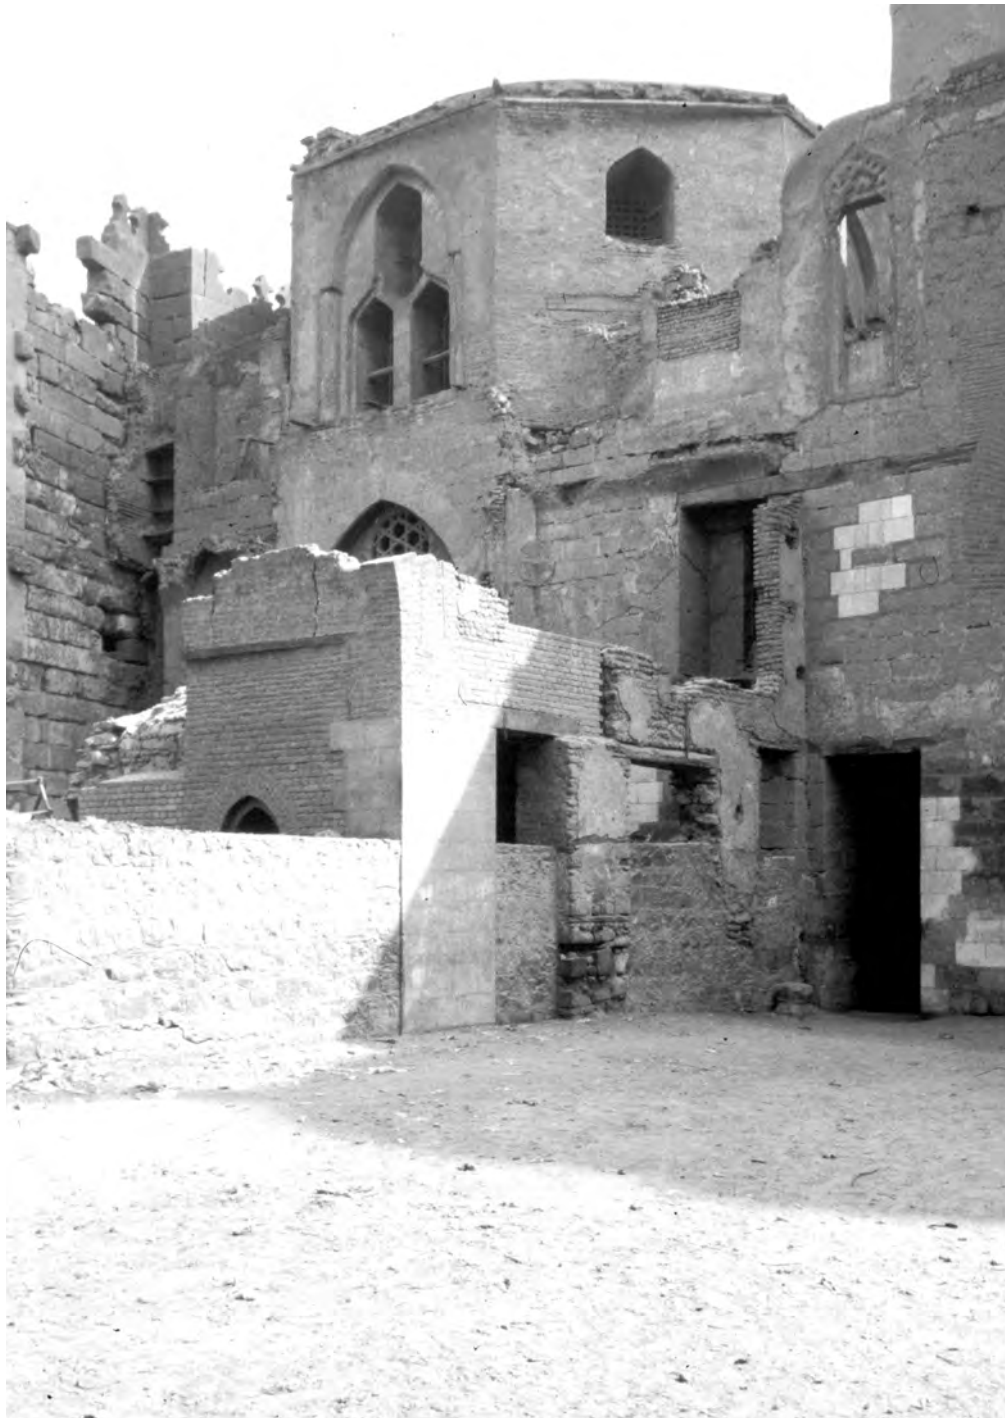
Fig. 12. Madrasah of al-Nāṣir MuḤammad, remains of northern iwān in front of the mausoleum, 1986 (Speiser)

This trial trench affects the part of the site immediately to the north-west of trial trench A, in which wall remains had been shown by an earlier investigation to be parts of the *iwān* on the north side. A modern storeroom abutted the north-west side, enclosed in the inner courtyard by a stretch of façade with two door apertures. On the north-east side is a cell with barrel vaulting, which, intriguingly, had an opening for ascending to the (now vanished) upper floor. The conclusion to be drawn from the unity of foundation and superstructure is that they most likely date from the Mamluk period. Their north-west wall, which is also the wall of the side *iwān*, still retains the historic spring of the vault in situ, which made it possible to reconstruct the pointed arch and barrel vaulting. When the side *iwān* foundation was uncovered, it was revealed that a wall niche had been set into its back wall. The two door openings mentioned above were slightly recessed from the uncovered threshold substructure, a clear indication that this was a historic reconstruction.

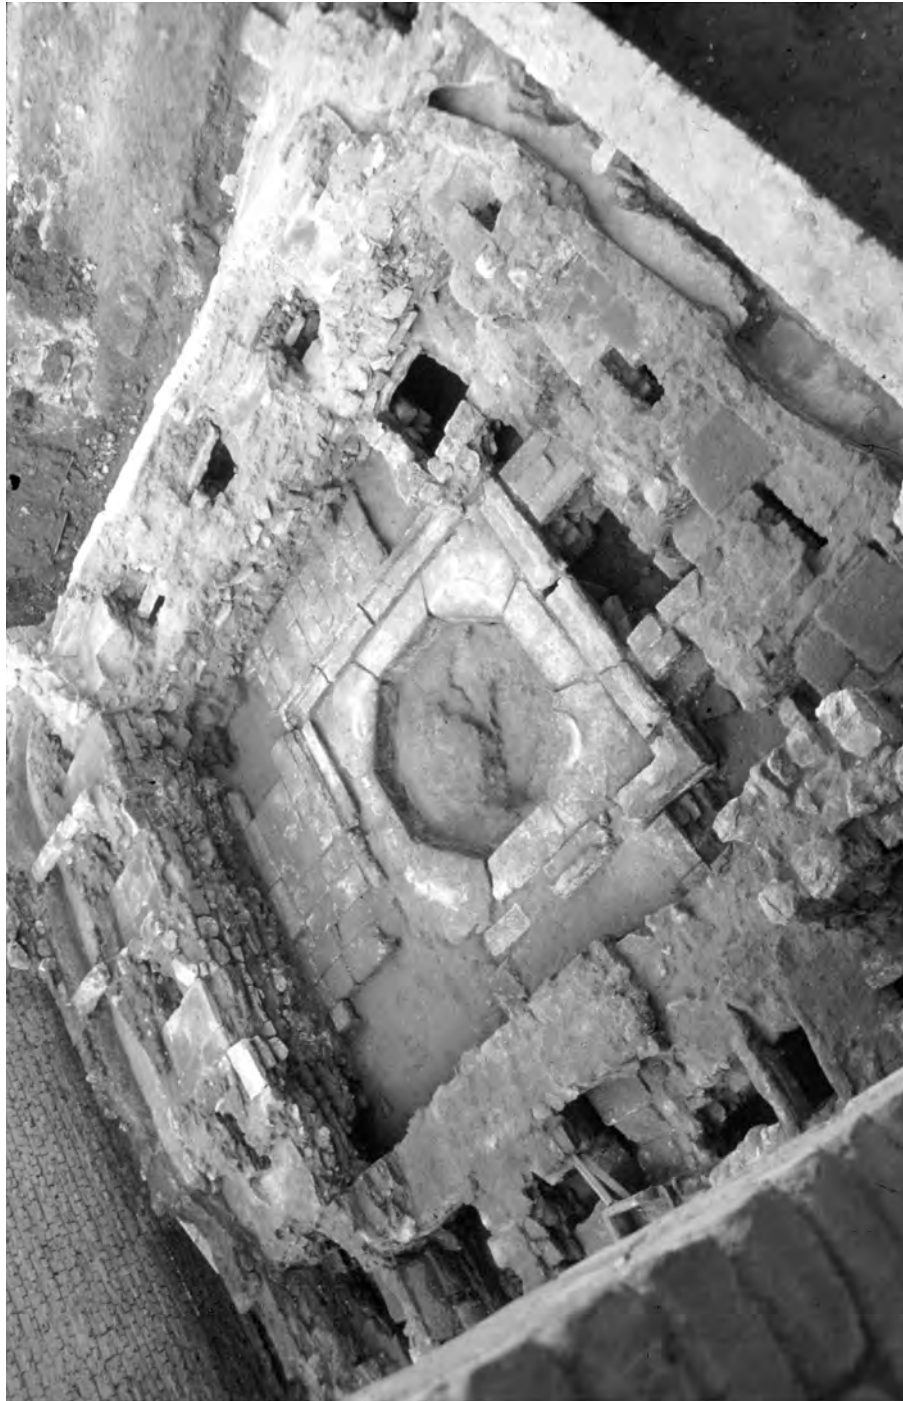
Fig. 15. Madrasah of al-Nāṣir Muḥammad, excavated Ottoman sanitary installations with Ayyubid basin in the center, 1998 (Speiser)

After the archaeological excavations had been finished, the sanitary installations and parts of the adjacent finds were preserved, and the excavated surfaces abutting the buildings of the two madrasahs were filled in with sand. The restored and partially rebuilt sanitary installations should be regarded as an “archaeological window” offering a glimpse of the earliest building stage in the Fatimid/Ayyubid era (tenth and twelfth centuries).
