PHILIPP SPEISER

INSTITUT FÜR BAU- UND STADTBAUGESCHICHTE, TU-BERLIN

The Sultan al-Nāṣir Muḥammad Madrasah in Cairo: Restoration and Archaeological Investigation

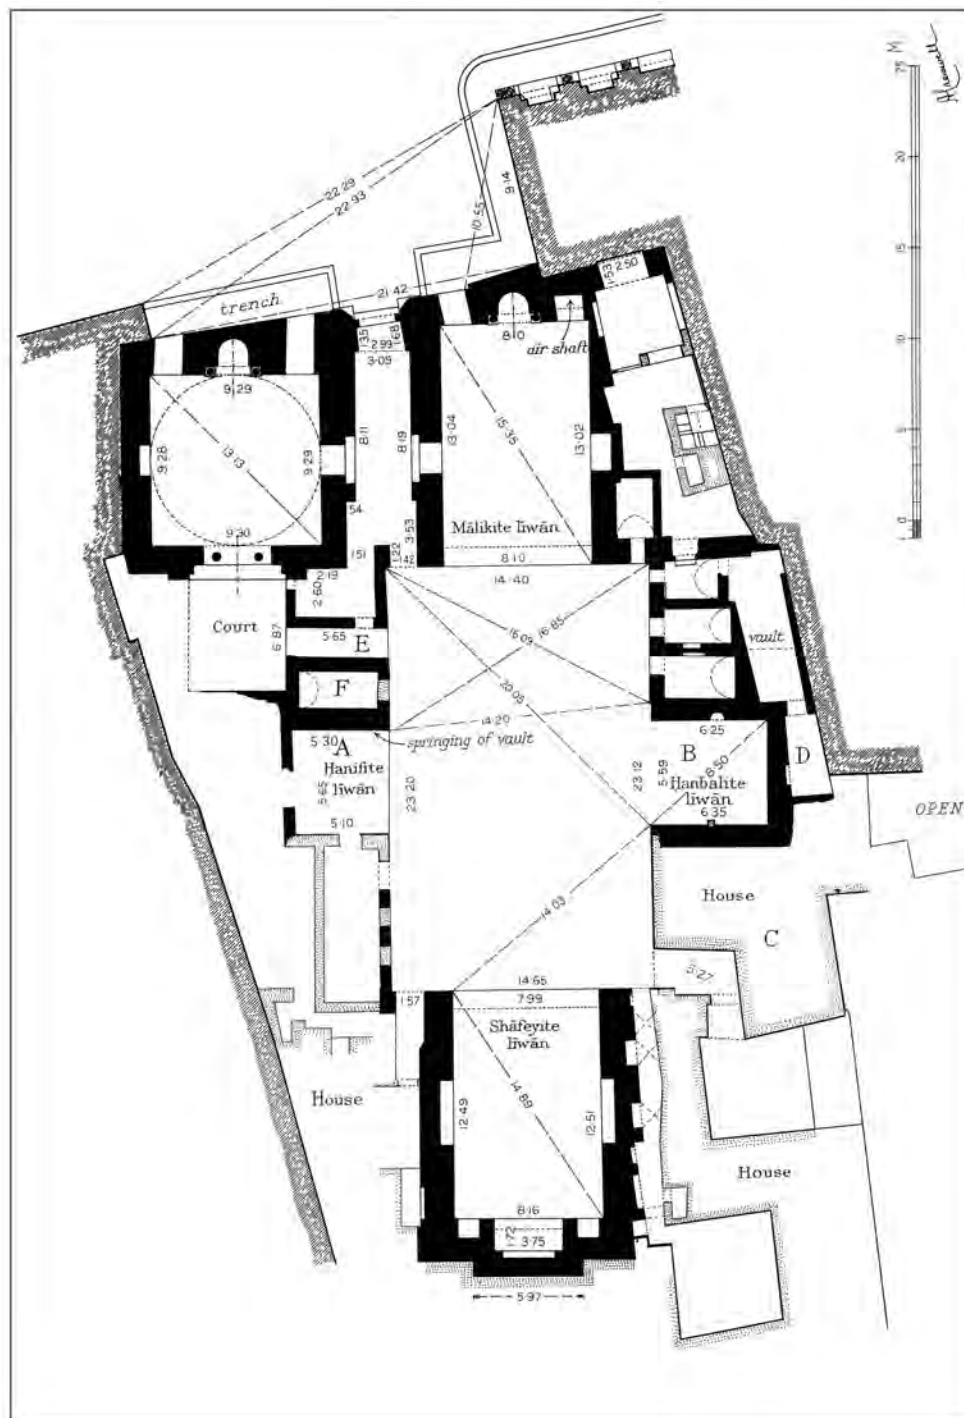
Fig. 2. Madrasah of al-Nāṣir Muḥammad, ground plan, 1959 (by K. A. C. Creswell)

The excavations confirmed the conjecture that the ground-plan provided for four *iwāns*. However, stratigraphic analysis showed that cells and remains of secondary or minor *iwāns* visible before 1985 on the long side of the madrasah and marked on Creswell's plan as Mamluk likely date from the Ottoman period (1517–1798) and later.³² The madrasah does not seem to have been properly maintained after the donor's death; to judge from the pottery finds, extensive restoration work was carried out in the sections along the long sides at a time that cannot be precisely ascertained. Further, the minaret was given a new tip and the mausoleum may have been topped with a wooden dome.

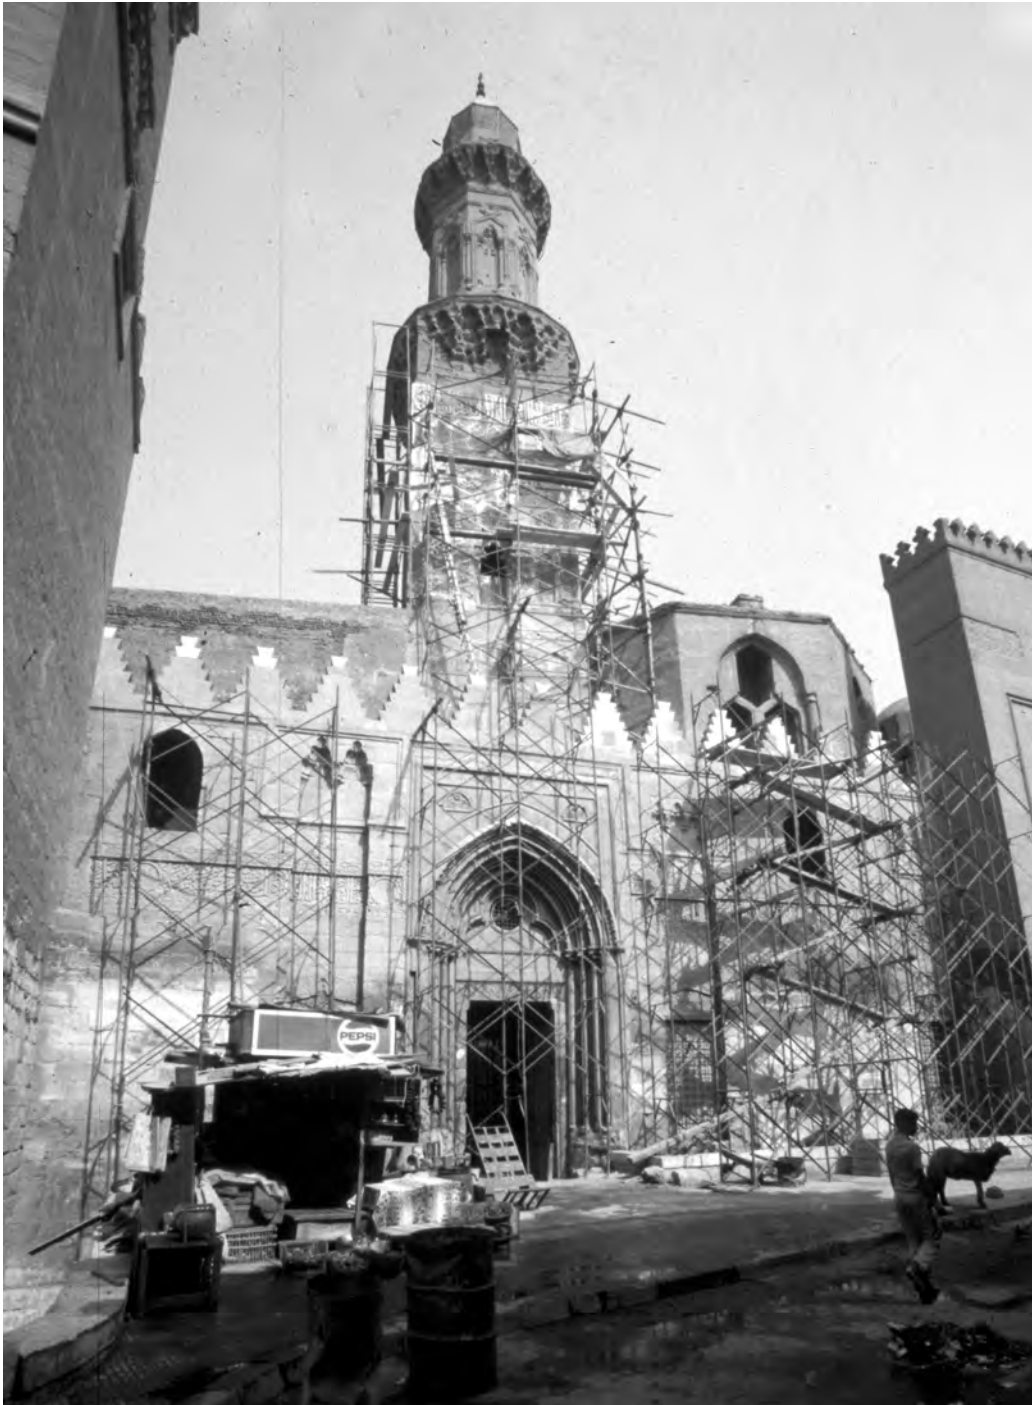
This inscription band is interrupted by the building's famous entrance portal, which divides the ashlar wall into two unequal segments. The southern segment, to the left as one faces the portal, measures 6.6 meters in length, and the northern segment, to the right, measures roughly ten meters. The portal is built around a marble doorway that formerly belonged to the church of St. Agnes in the Crusader-occupied town of Acre and was brought to Cairo by order of Sultan Ashraf Khalil ibn Qalāwūn, an elder brother of al-Nāṣir Muḥammad, after the Mamluk recovery of Acre in 1291.⁶ The portal thus consists of concentric Gothic arches, echoing this doorway, framed by a rectangular molding which is a Mamluk addition, which rises to stop just short of the horizontal molding at the top of the wall. The doorway allows equal entrance to both the mausoleum and the madrasah.

Immediately on either side of the portal are tall vertical recesses, both of which have barred fenestration on the ground-floor level. Above the inscription band, these vertical recesses enter oblong spaces or panels created by molding that merges with the horizontal molding along the top of the ashlar wall. The recess on the left (south-eastern) side of the portal rises the full height of the wall and culminates in two lobes with carved decoration, which terminate with the horizontal molding at the top of the wall. The recess on the right (north-western)

Fig. 10. Madrasah of al-Nāṣir Muḥammad, street elevation during restoration, 1986 (Speiser)

1. Securing the masonry and replacing damaged and missing parts: this affected most parts of the complex and especially the south-west wall of the qiblah *iwān*, the street façade with its unrendered ashlar masonry, and the mausoleum masonry. The crown molding of the walls and some of the crenellation on the street side had to be rebuilt.
